BOUNDARY ENGINEERING

Machining Division

Relief Valve Failure Analysis

2/23/2010

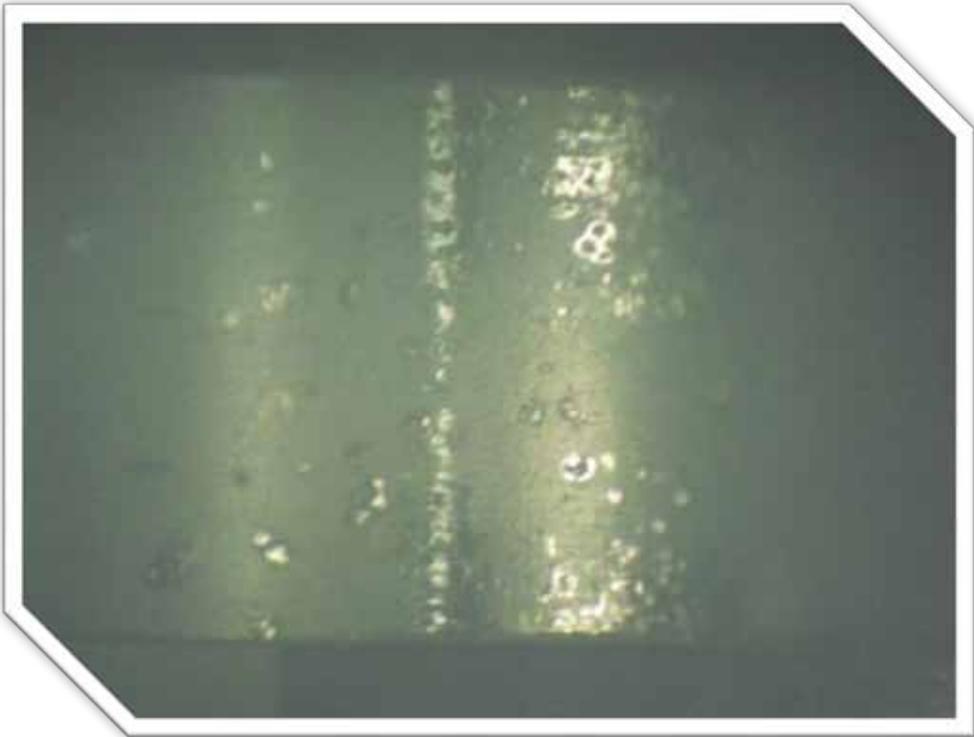
Inner gear picture showing damage. Magnification 10X

The damage in the above photos on the inner gear is suspected to be caused by debris harder than Rockwell C-14 entering the pump. Pictures were taken using an optical comparator and a standard microscope, using a CCD device to obtain images from the Microscope.

- 2) The gear teeth show multiple pock marks of varying depths and widths on their teeth. Some pocks are wider than .01 in., unfortunately the depth is something I cannot measure.

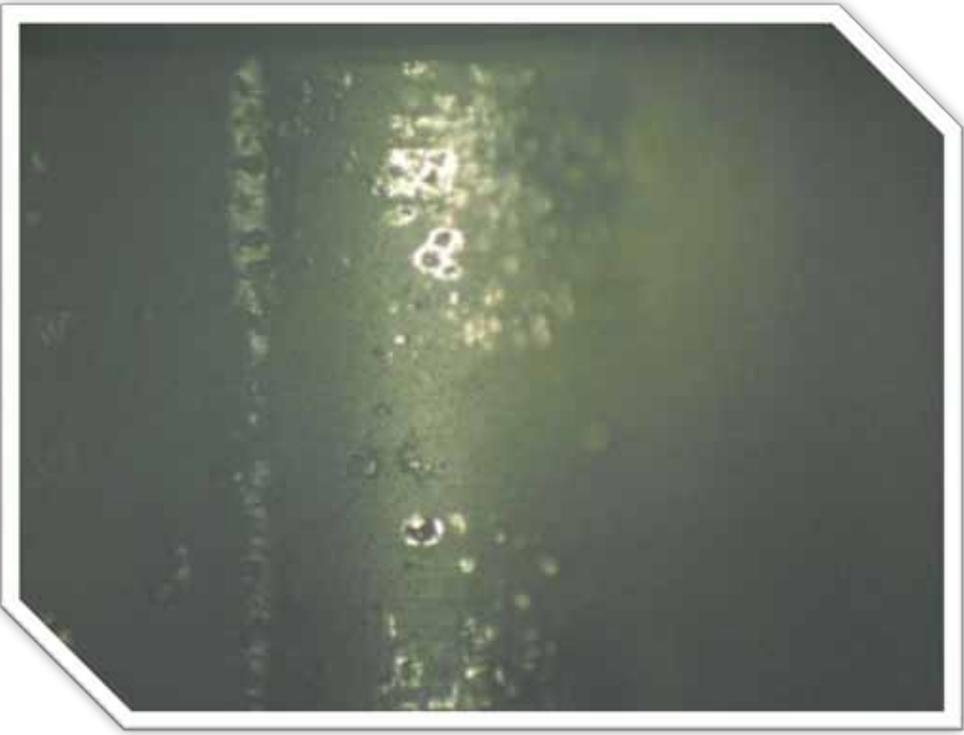
Inner Gear Picture showing damage 2. Magnification 10X

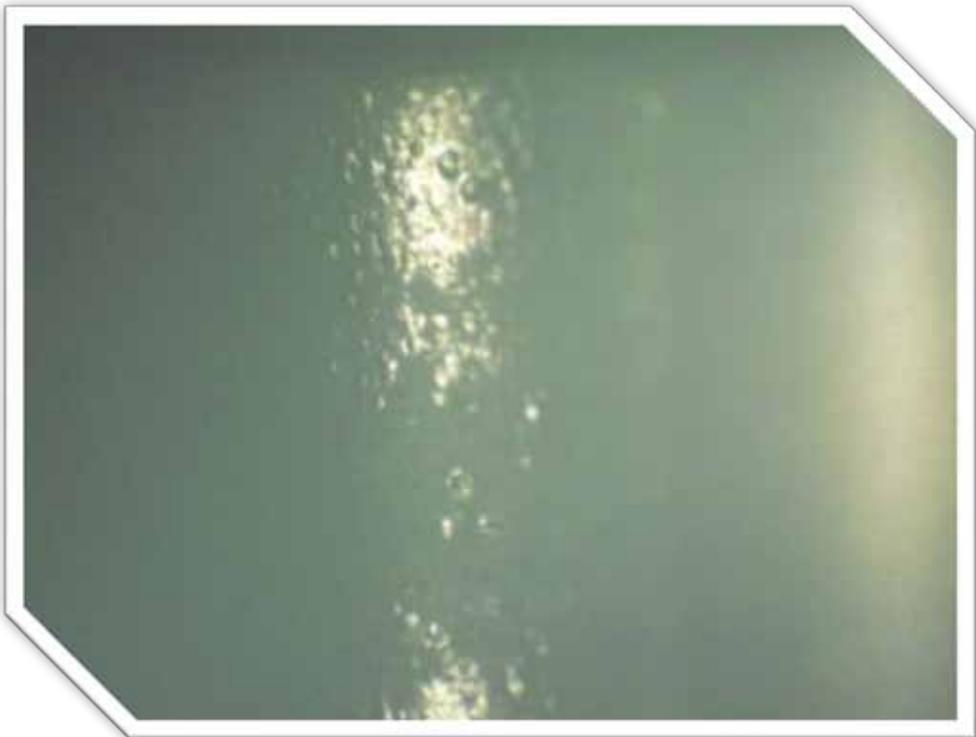
Inner gear picture showing damage 3. Magnification 10X

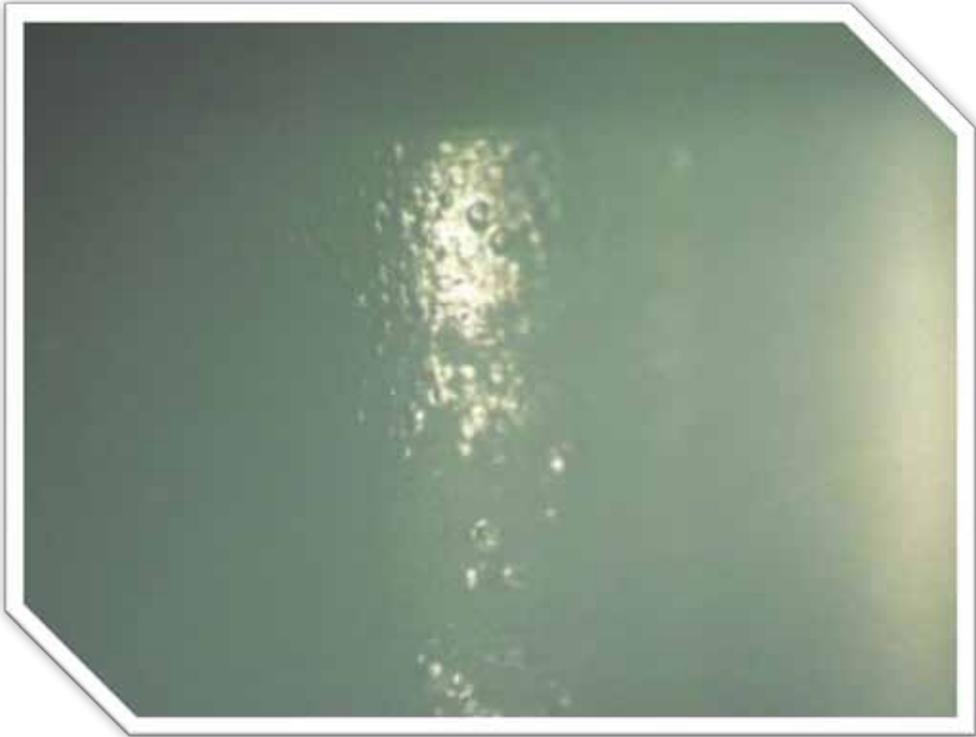
Inner gear picture showing damage 4. Magnification 10X

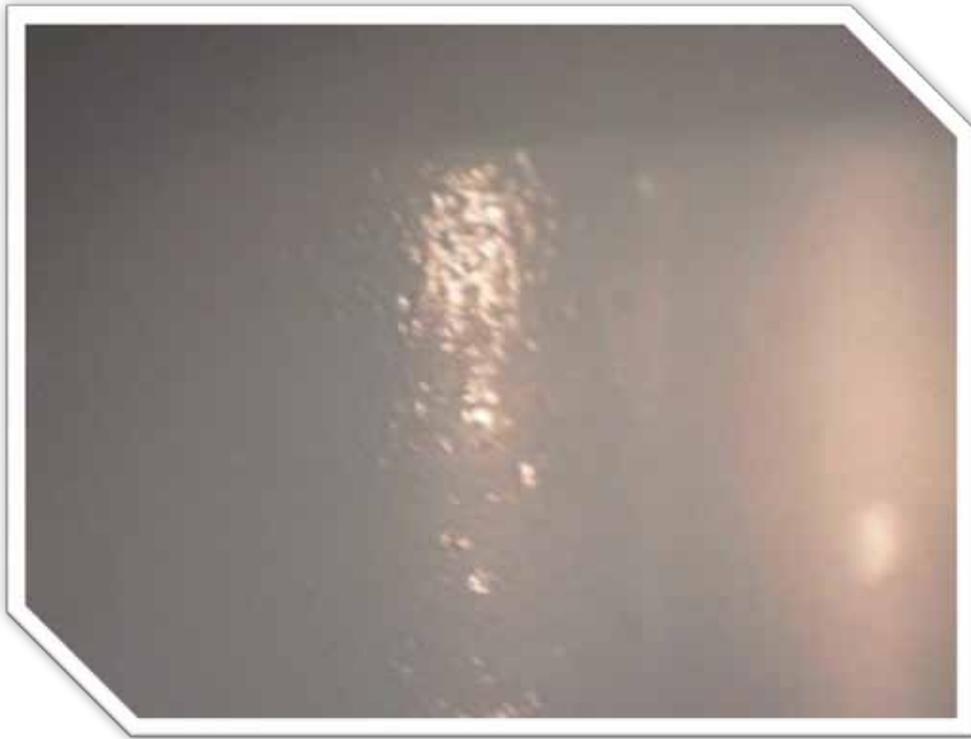
Inner gear picture showing damage 5. Magnification 10X

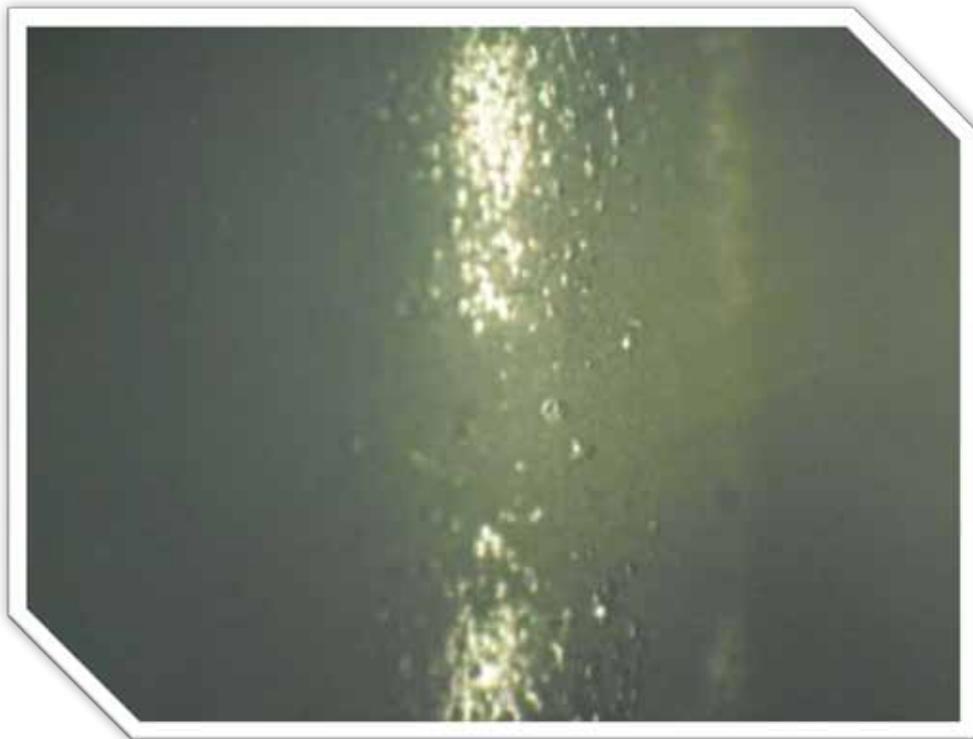
Inner gear picture showing damage 6. Magnification 10X

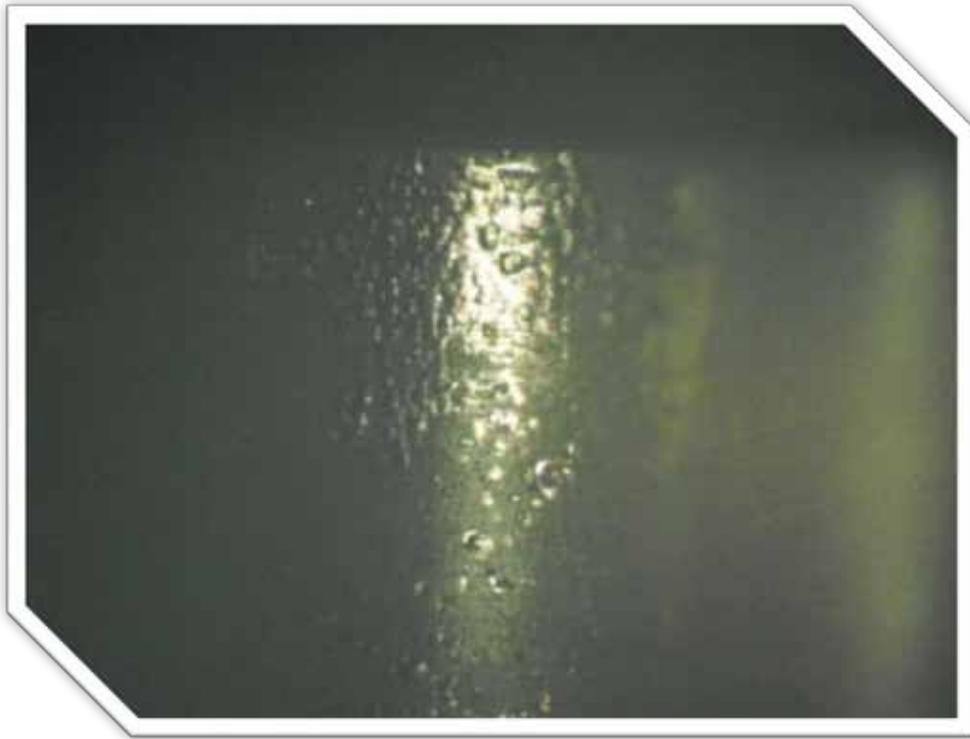
Inner gear picture showing damage 7. Magnification 10

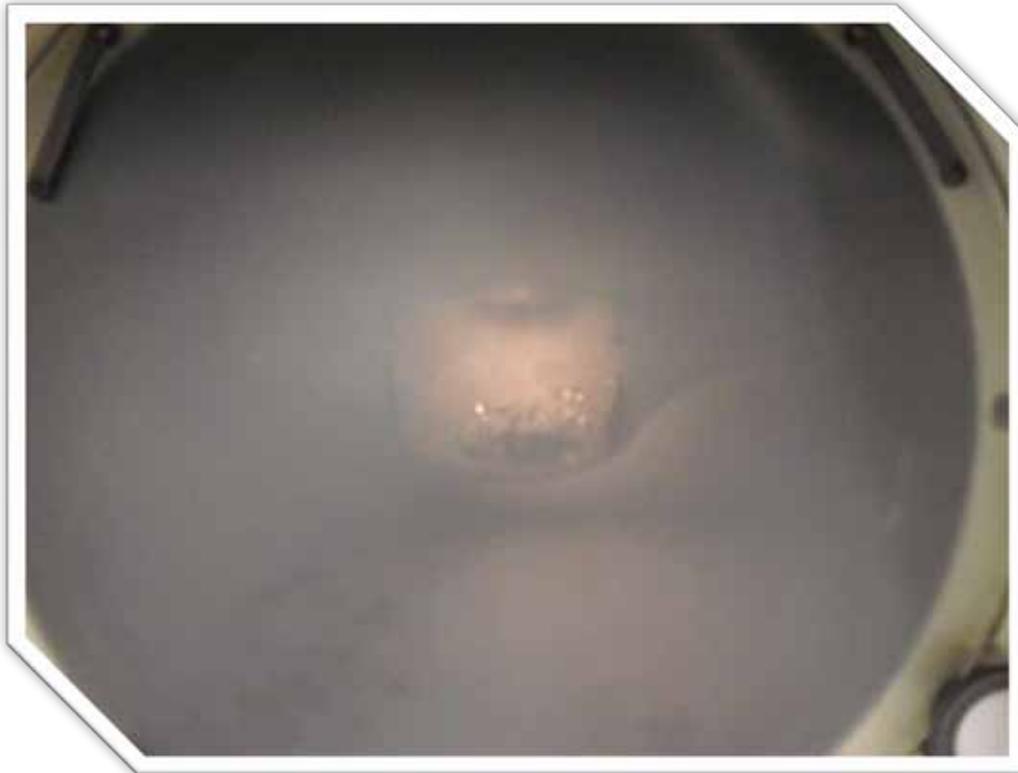
Outer gear showing damage:

It is suspected that foreign debris harder than Rockwell C-16 entered the oil pump and damaged the sides. Pictures were taken using an optical comparator and a standard microscope, using a CCD device to obtain images from the Microscope.

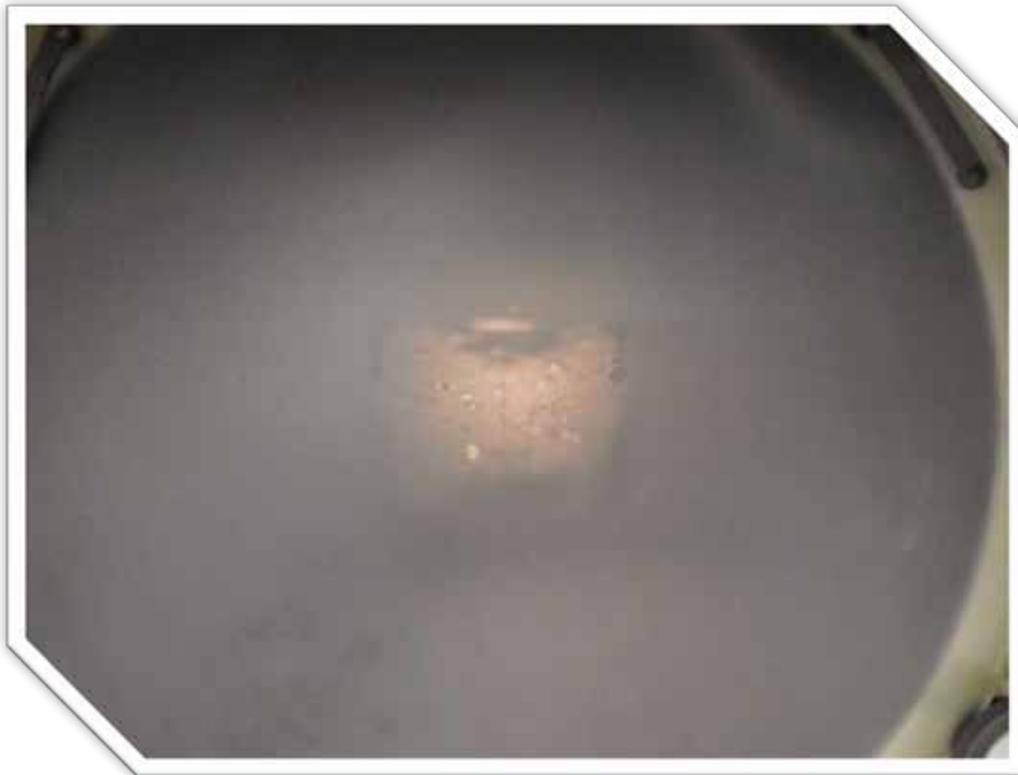
Outer gear showing damage 2:

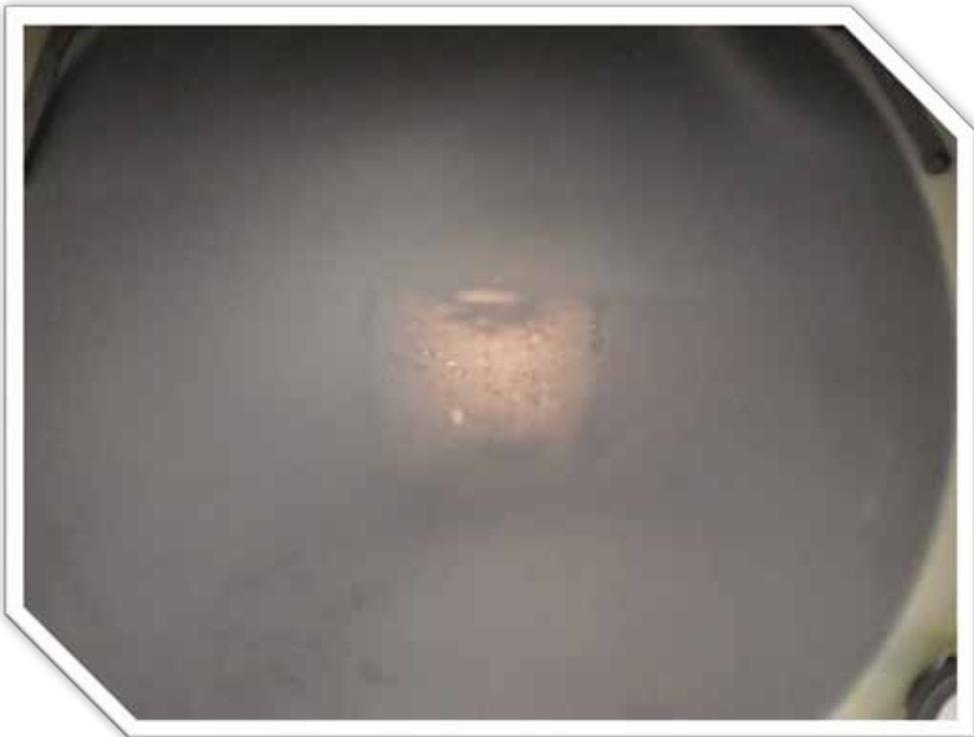
Outer gear showing damage 3:

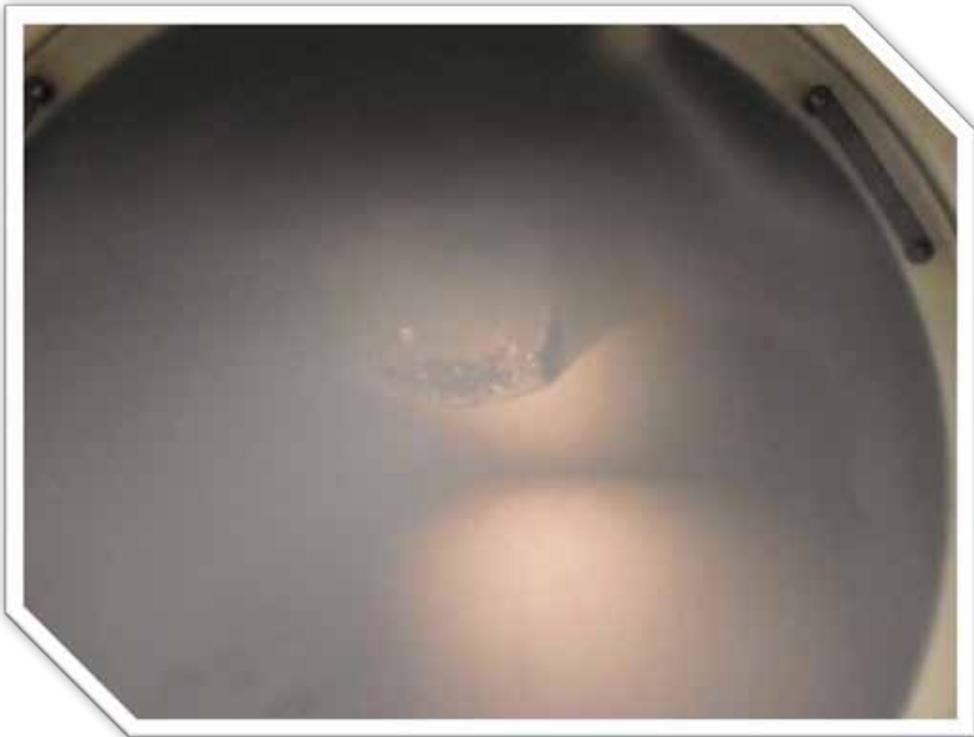
Outer gear showing damage 4:

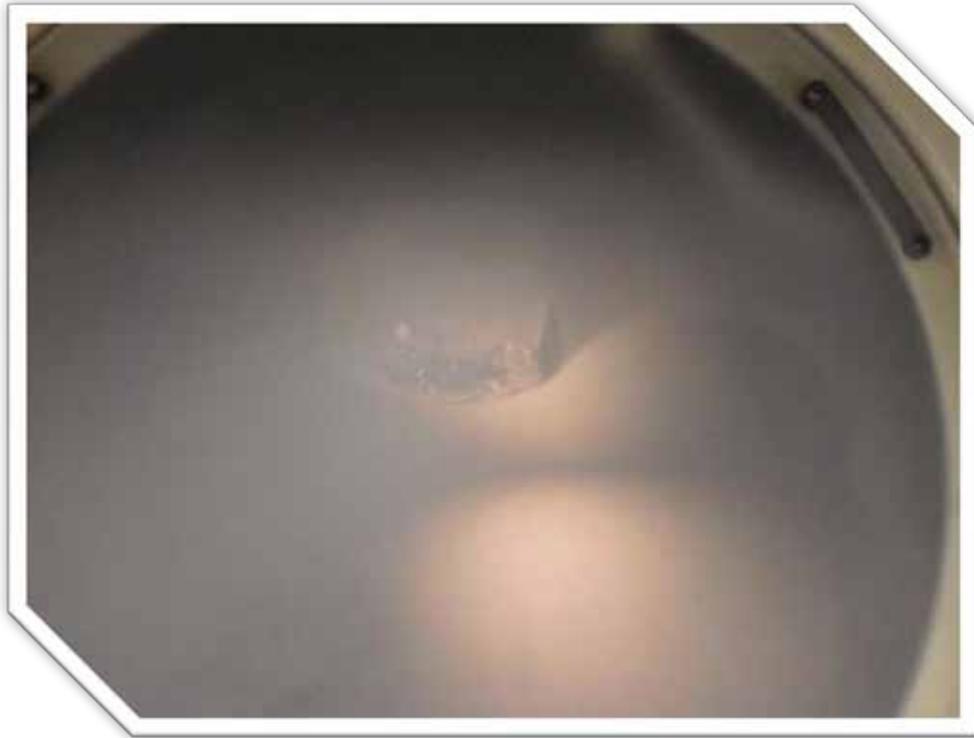
Outer gear showing damage 5:

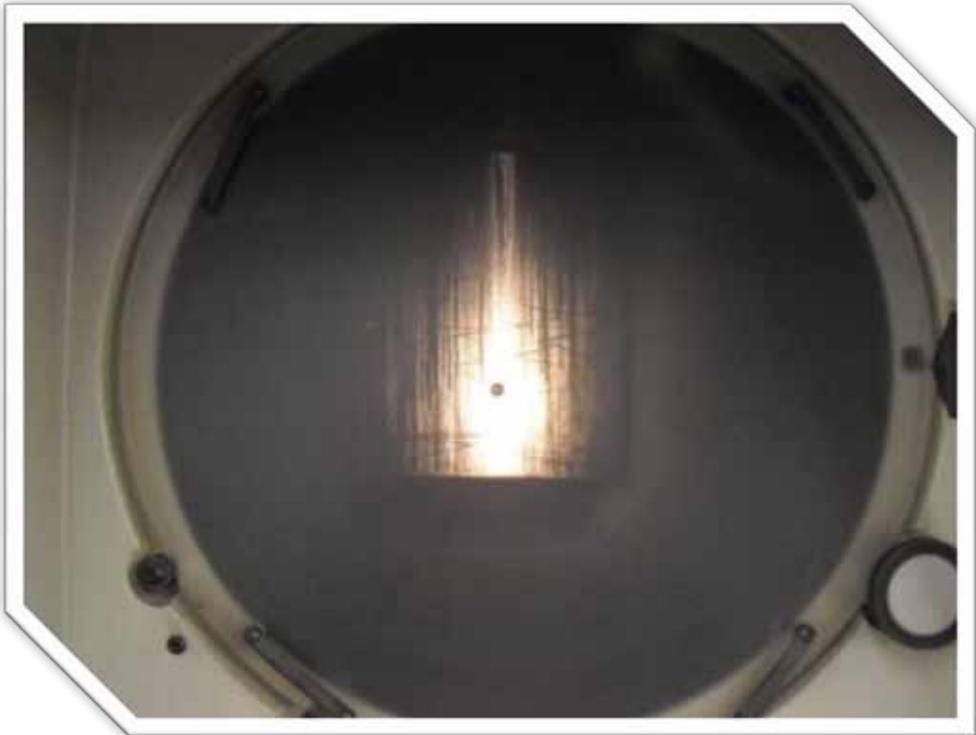
Piston showing damage:

The damage caused in the above pictures is believed to be from foreign particles harder than Rockwell C-25 hardness that entered the oil pump. Pictures were taken using an optical comparator and a standard microscope, using a CCD device to obtain images from the Microscope.

- 3) The piston has multiple scoring marks on the OD. Some are the whole length, others go about half way. There are even some scratch marks that circle the piston but I believe them to be from removing the piston after the damage.

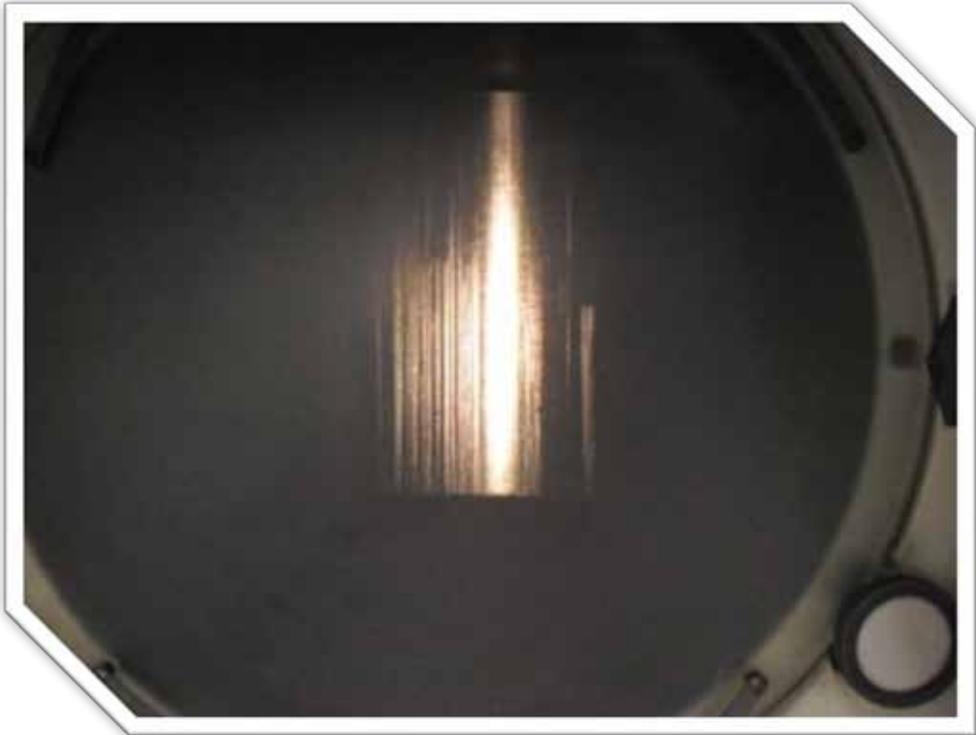
Piston showing damage 2:

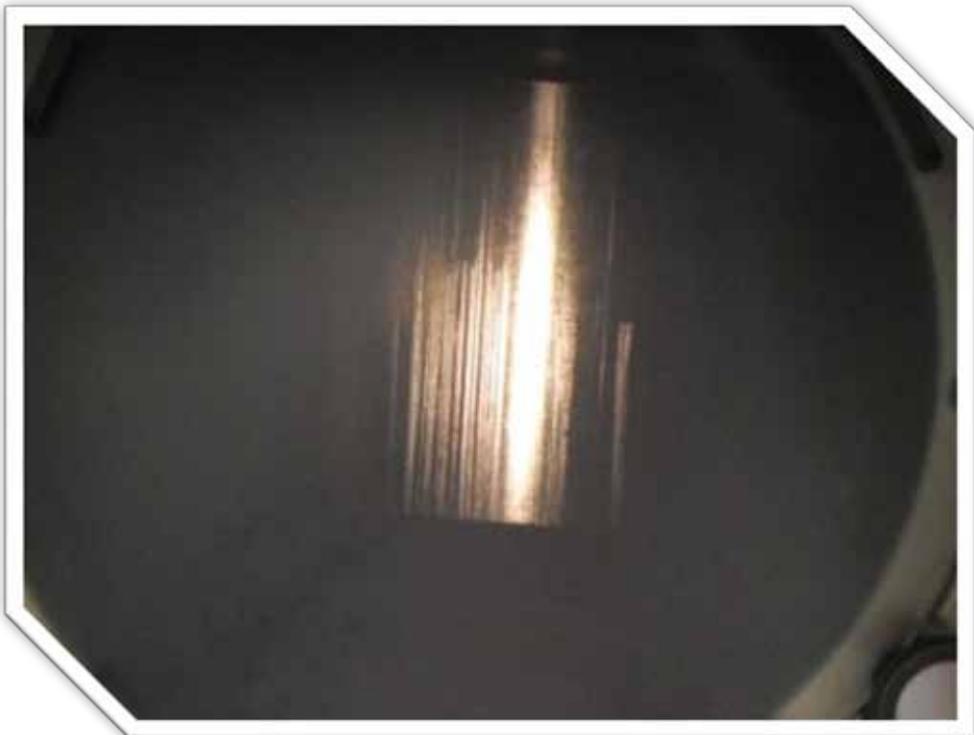
Piston showing damage 3:

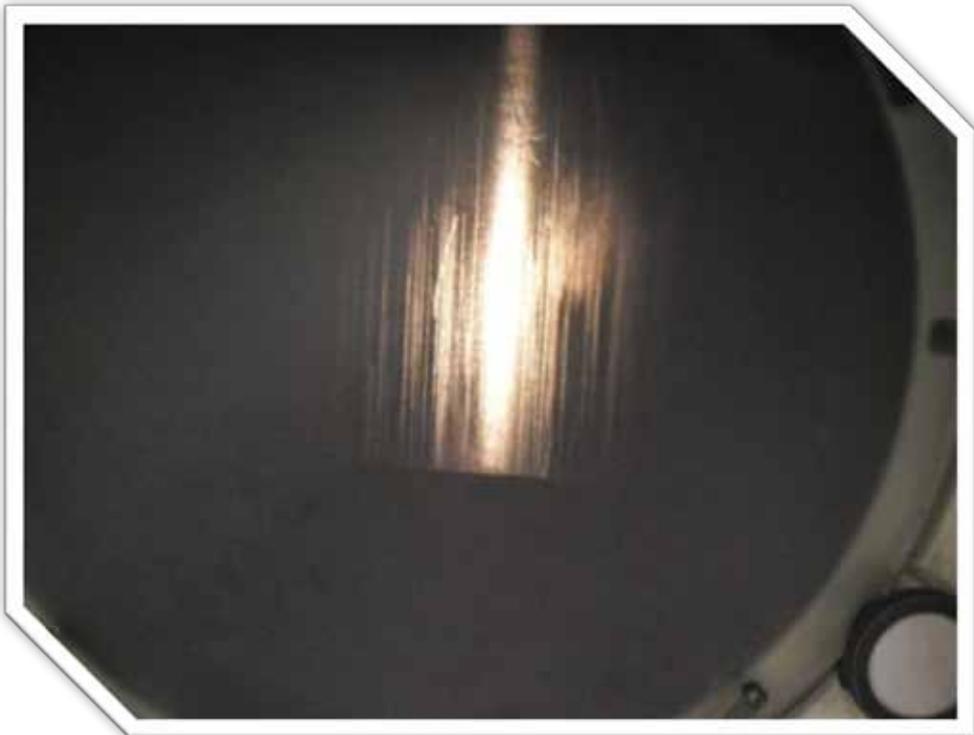
Piston showing damage 4:

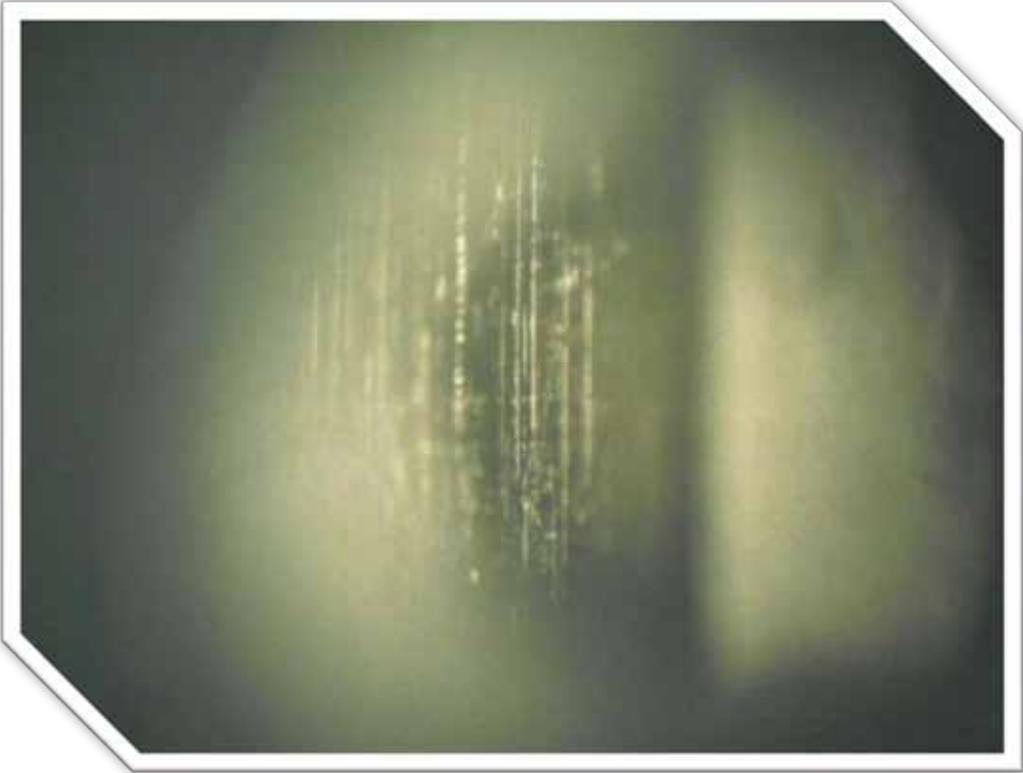
Relief valve cylinder showing damage:

- 4) The housing's cylinder walls have multiple scoring marks as well. There are bits of a foreign material embedded in the wall. This material is magnetic as I chipped a piece out and tested it with a magnet.

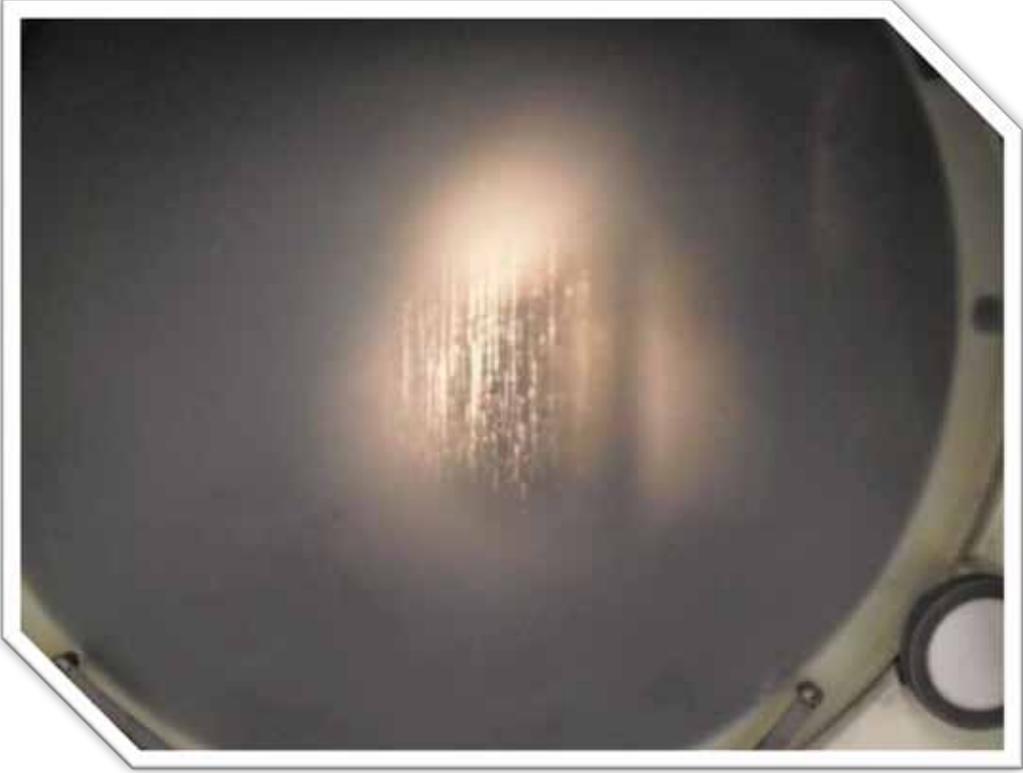
Relief valve cylinder showing damage 2:

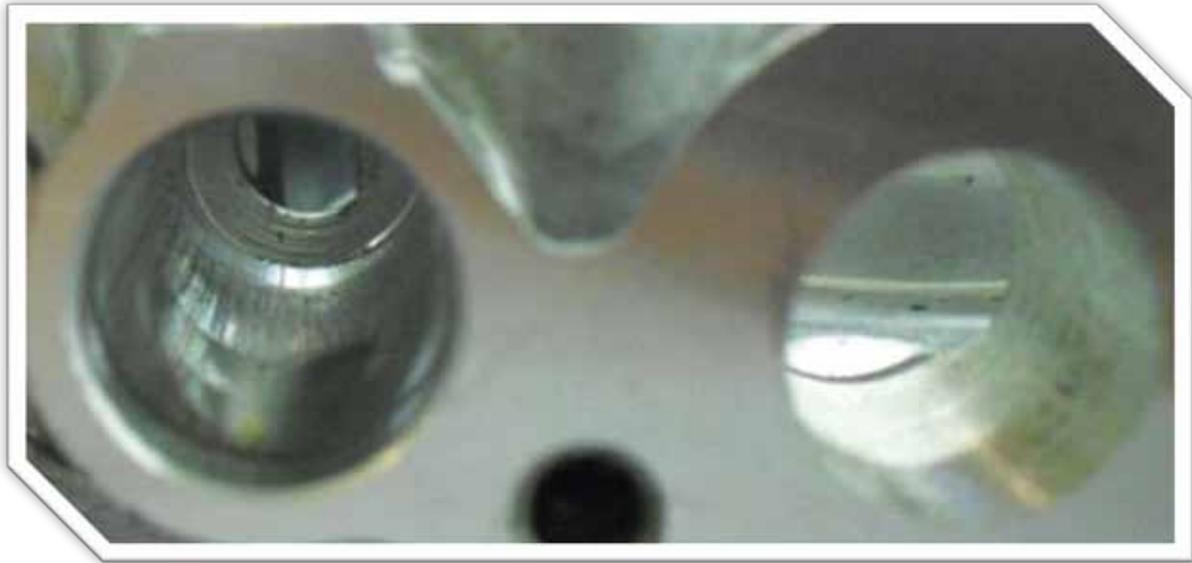
Relief valve cylinder showing damage 3:

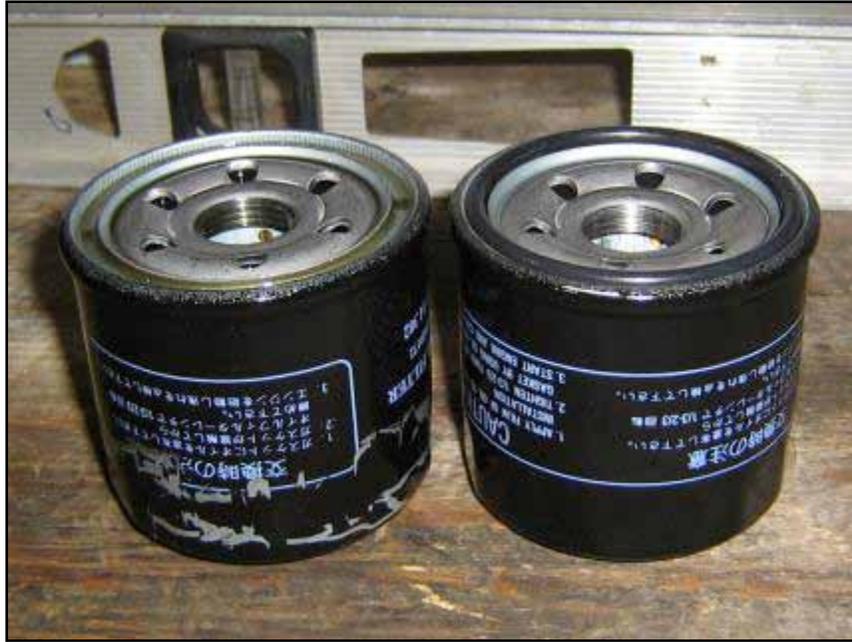
Item 1: Oil filter damage

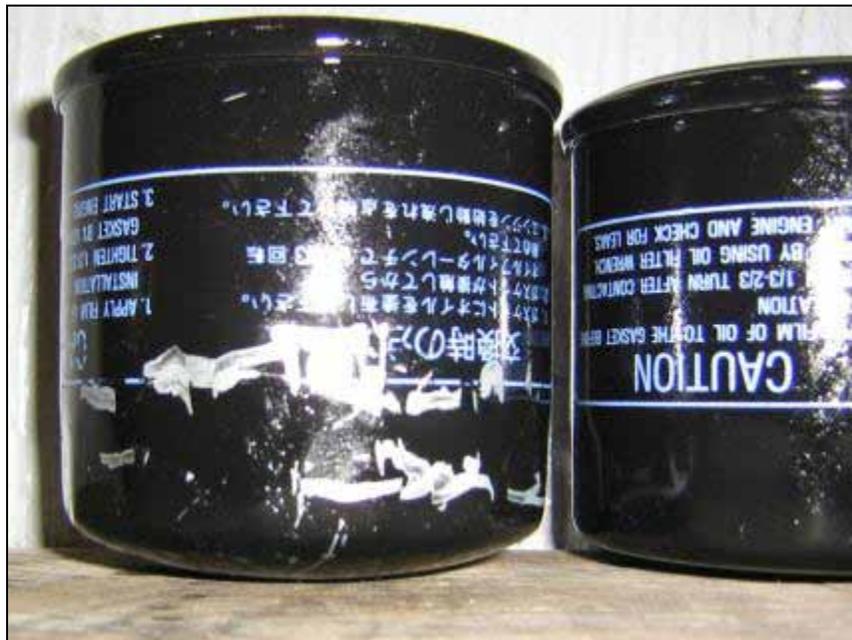
Item 2: Oil filter damage 2

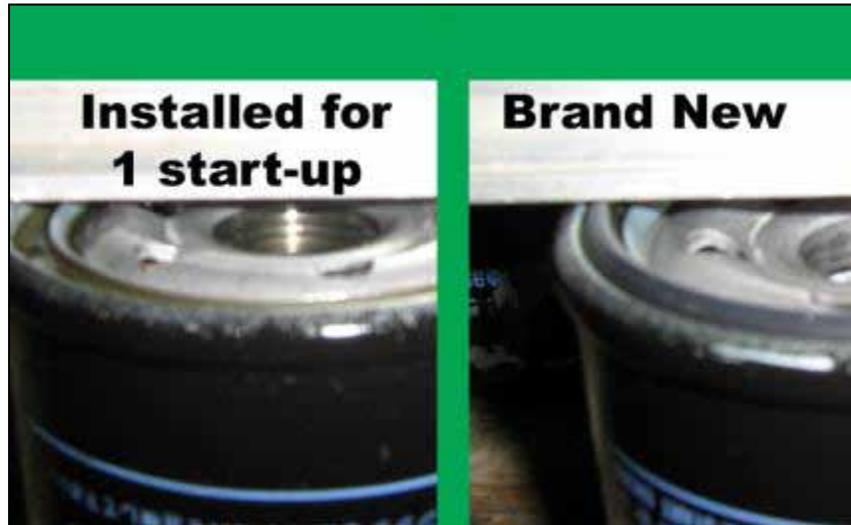
Item 3: Oil Filter Damage 3
