Service Bulletin

Category S	Applicable Model/s 1994-97 MX-5 Miata	Subject THUMPING OR POPPING NOISE FROM FUEL TANK AREA	Bulletin No. 017/97 Issued 07/16/97 Revised
---------------	---	---	---

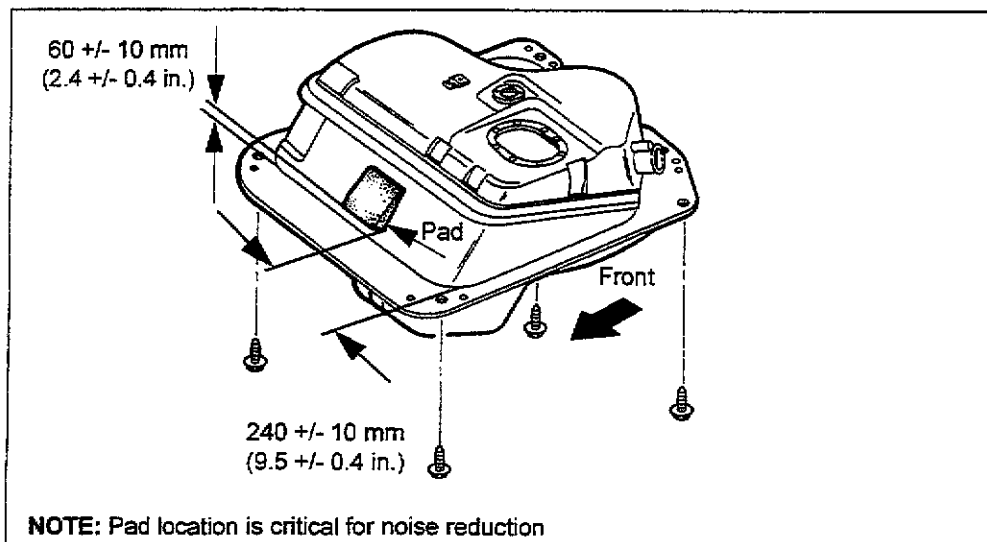
The noise is caused by a slight torsion of the fuel tank and a change in temperature. A pad has been added to the fuel tank upper pan to reduce noise. Customers complaining of this noise should have the vehicle inspected and if necessary have a pad installed according to the procedure below.

4. Add pad to the position indicated in the illustration below.
5. Re-tighten the fuel tank installation bolts to the correct torque, 21-30 Nm (2.1-3.1 kgf.m, 16-22 ft.lbs.)
