BOUNDARY ENGINEERING

Machining Division

Relief Valve Failure Analysis

2/23/2010

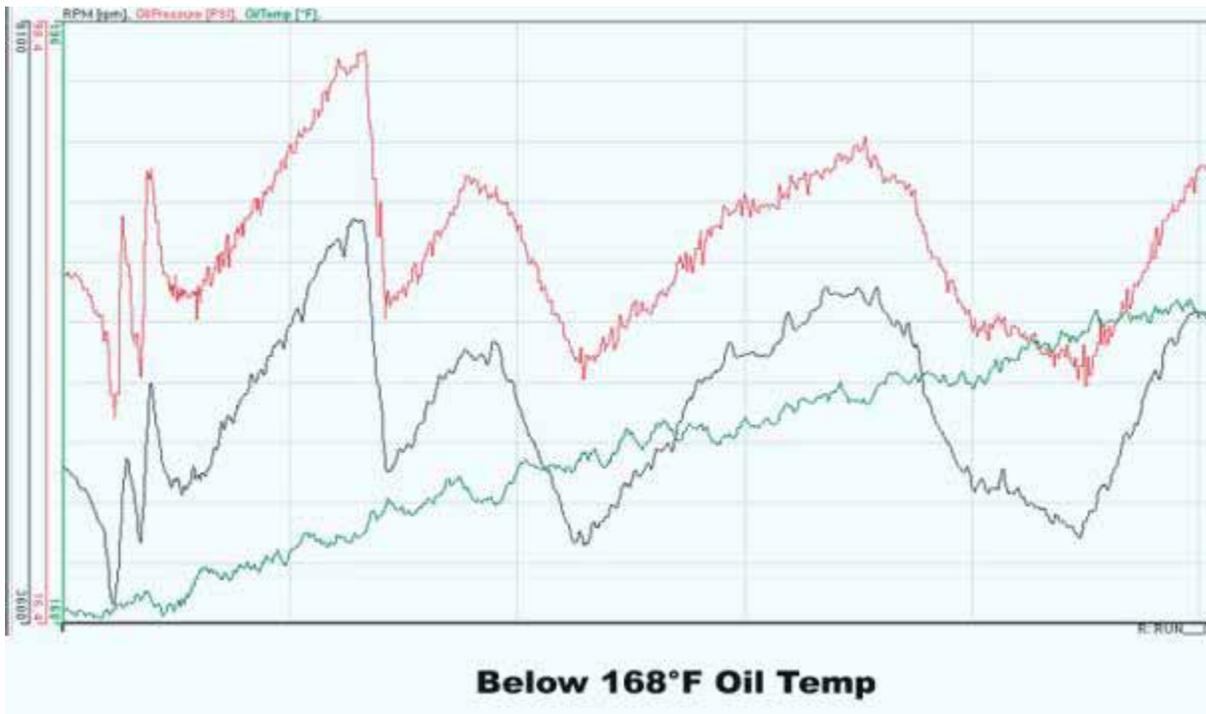
Item 4: Oil pressure with respect to RPM and temperature.

The customer states that the pressure is extremely high. The engine has been run, and broken in. He reports that the pressure remains high until 170°F in oil temperature. Below 150°F oil temperature the oil pressure is beyond the capability of either the oil pressure gauge or the software to monitor. Customer also reports that the oil filter is deforming under pressure.
